## Specific problem solution and distant learning

David L. Kastler  
*University of Northern Iowa*

This document is an overview of a project to identify the cause of a coolant overheating complaint on a diesel engine that powers a mechanical lift machine, implement a short-term solution and place into action a long-term solution. The short-term correction was to make necessary repairs in the field, long-term solution includes distant training of the mechanical lift machine assembly line and training on the proper assembly procedure of assembling the alternator pulley to the alternator shaft.

A Graduate Project Paper

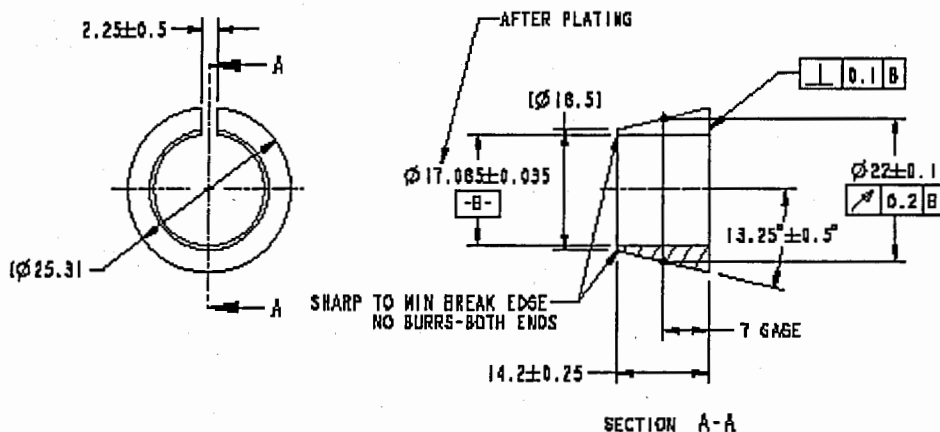
This is the drawing of the part number R94351 .

We will measure 10 parts(R94351) to print and verify if all the characteristics meet the specification .

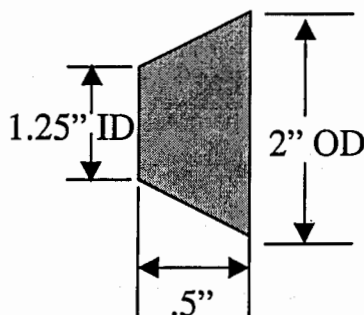
Mechanical Lift states that some of the RE504096 kits are missing the R94351 collar or they have a collar that measures of 2" OD, 1.25" ID and .5" wide/deep. The drawing below is of a part, which Mechanical Lift is finding in the RE504096 kit.

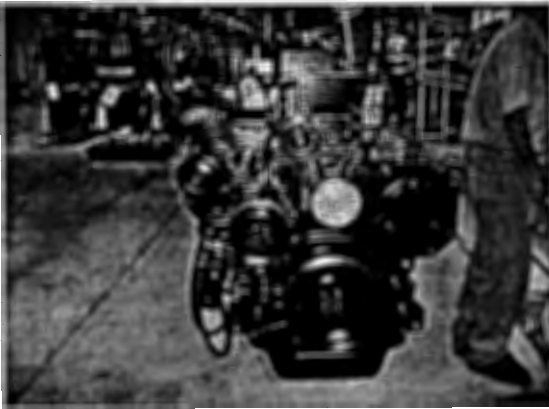
This picture shows the engine with its bracket, just before the alternator is assembled. It is the starting point.

Question #1, Is there much tolerance (size of bolt hole) between the bolt hole and the bolts?

Can the bracket move much on the bolts?

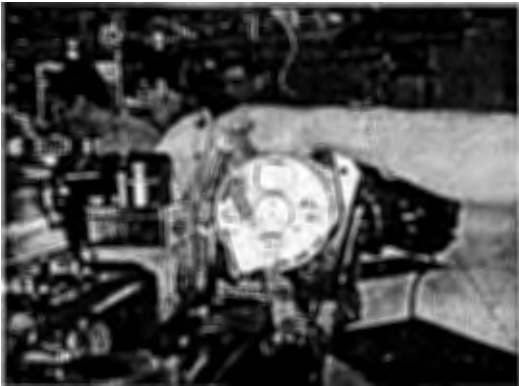
The bushing is completely introduced to the bolt by hitting it softly with a hard object (we use a socket).

Question #3, Assembly person taps the bushing so it completely contacts the alternator housing?

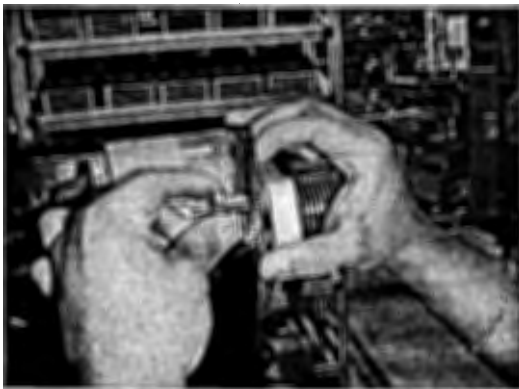
Question #4, At this point, if there is a big gap where the washer goes, do you loosen the bracket mounting bolts or any other steps for aligning parts?

We really do not experience this problem during assembly. We never loosen the bracket mounting bolts.

Then the bolt and washer are installed manually on the left hand side bracket hole. The washer goes between the bracket and the alternator. The bolt is hand tightened.

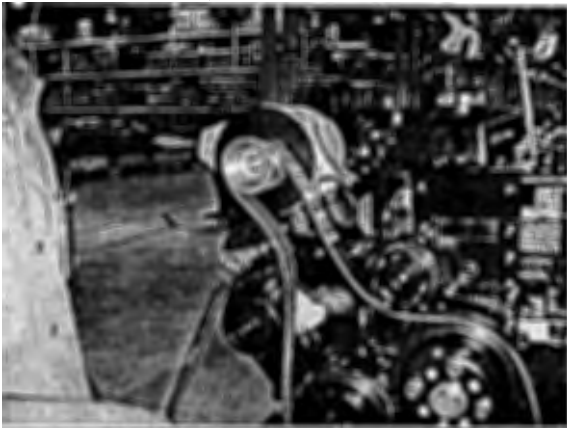
The belt is placed, making sure that it is completely seated on all pulleys.

Question #5, Does the assembly line ever check to see if the pulleys are aligned?

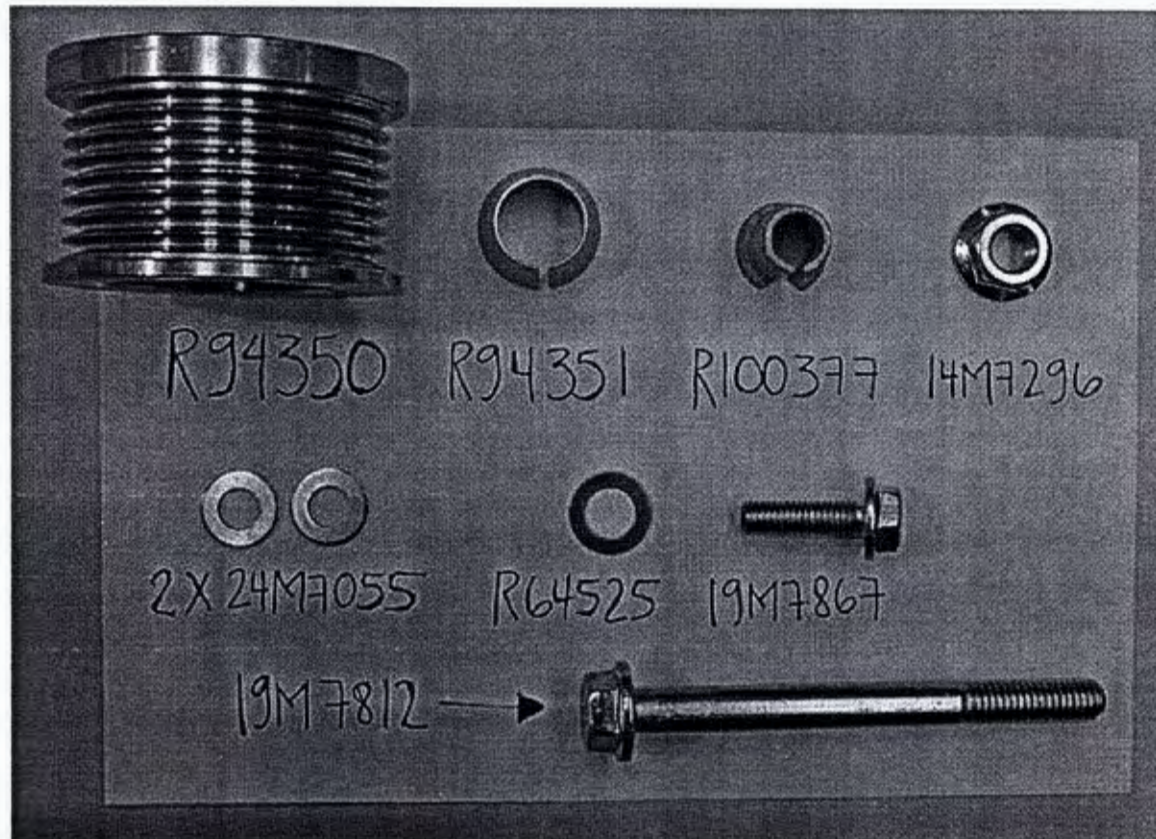
Photo of the parts shipped from the Diesel Engine factory for each Mechanical Lift engine.
